COUNTIES (MD/PA) _	WASHINGTON/FRANKLIN
M&D milestone no	103 (106)
MHT-HSI no.	WA-I-274
? PROTECTED ENDAN	IGERRIX/ANDSSANCE

FIELD SHEET: MASON & DIXON LINE, MARYLAND-PENNSYLVANIA BOUNDARY MARKER SURVEY

MASON & DIXON WEST LINE: MILESTONE 103(106)

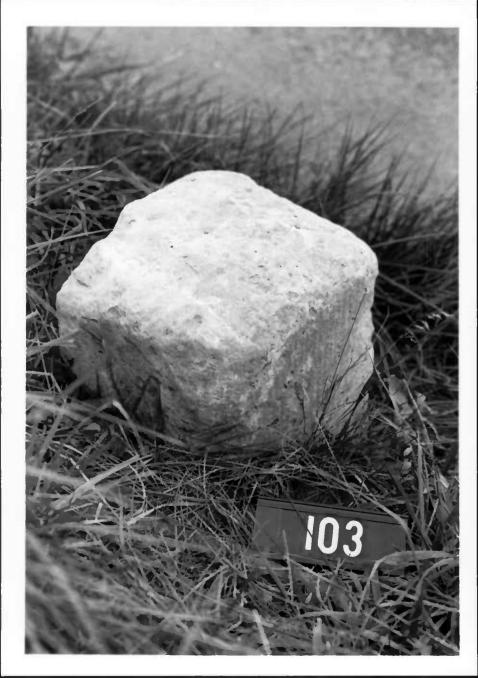
SE CORREL (M/-)

1979-81 Inspection notes: order no. 103 (100; photos/negatives/slides no.103(106) 103 (106). Original M&D milestone of 1767 relocated slightly to east and reset 1902, believed recently shifted again; in fairly good condition, firmly set.

Letters clear but chipped; all surfaces scarred, chipped and weathered.

5x7 SE corner (1980.23.33), "

Anywhere along this stretch is an unfortunate location, very close to increasing traffic and vulnerable to vandalism. MGS will want to erect some kind of witness post (when site is verified), preferably sturdy enough for protection from vehicles.

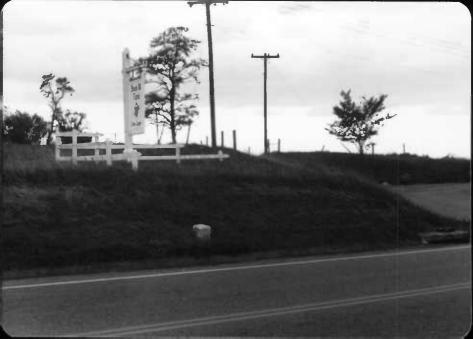
PHOTO: ALKE HARTIN (1984.23,35) 10/12/80

3½x5 View S across State Line Rd toward stone & farm lane (1980.23.35), Alice Martin 10/12/80

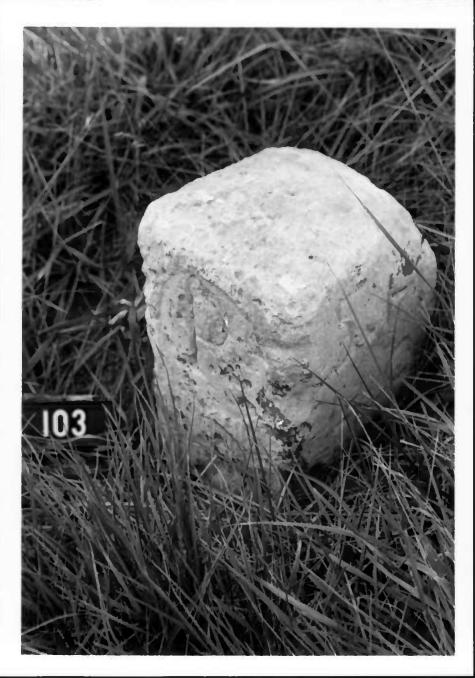
PHOTO: ALICE HARTIN (1990. 23.31) 10/12/80

5x7 NW corner (1980.23.31), Alice Martin 10/12/80
